UNDERWATER BRIDGE INSPECTION REPORT

STRUCTURE NO. 74539
WEST BRIDGE STREET
OVER THE
STRAIGHT RIVER
DISTRICT 6 - STEELE COUNTY

PREPARED FOR THE
MINNESOTA DEPARTMENT OF TRANSPORTATION
BY
COLLINS ENGINEERS, INC.
JOB NO.5221

MINNESOTA DEPARTMENT OF TRANSPORTATION
UNDERWATER BRIDGE INSPECTION

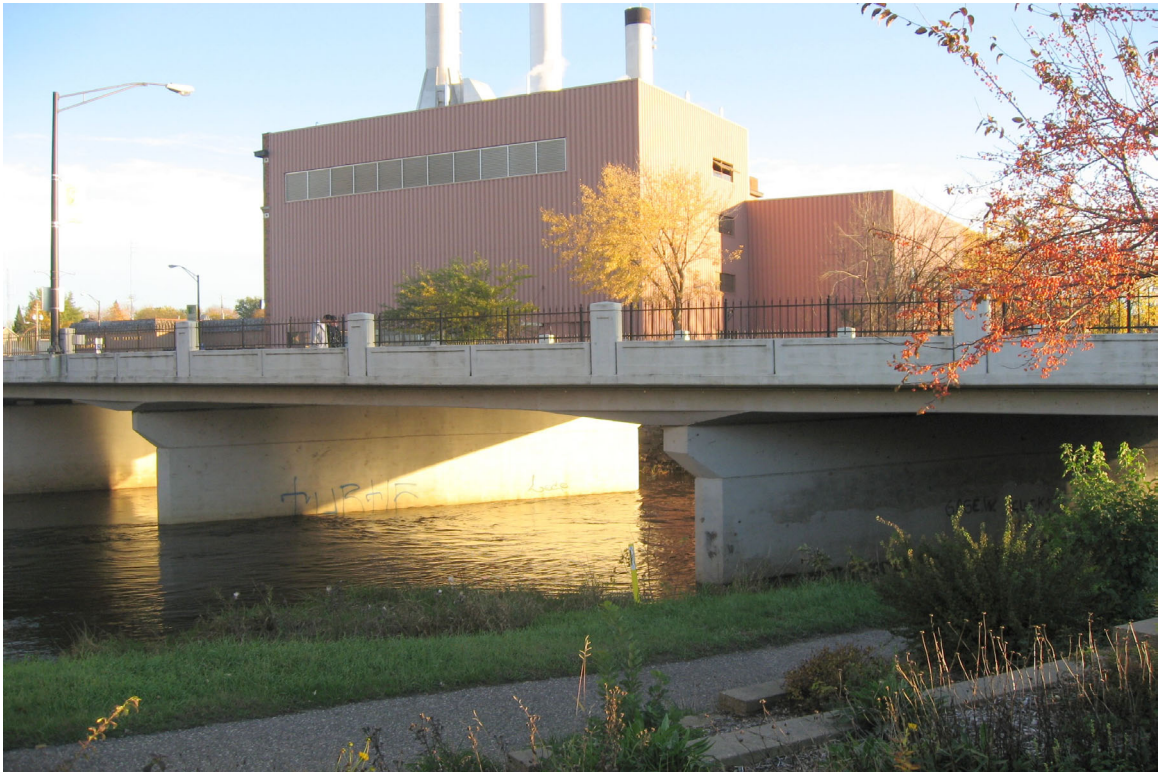
Photograph 1. Overall View of Bridge, Looking Southeast.

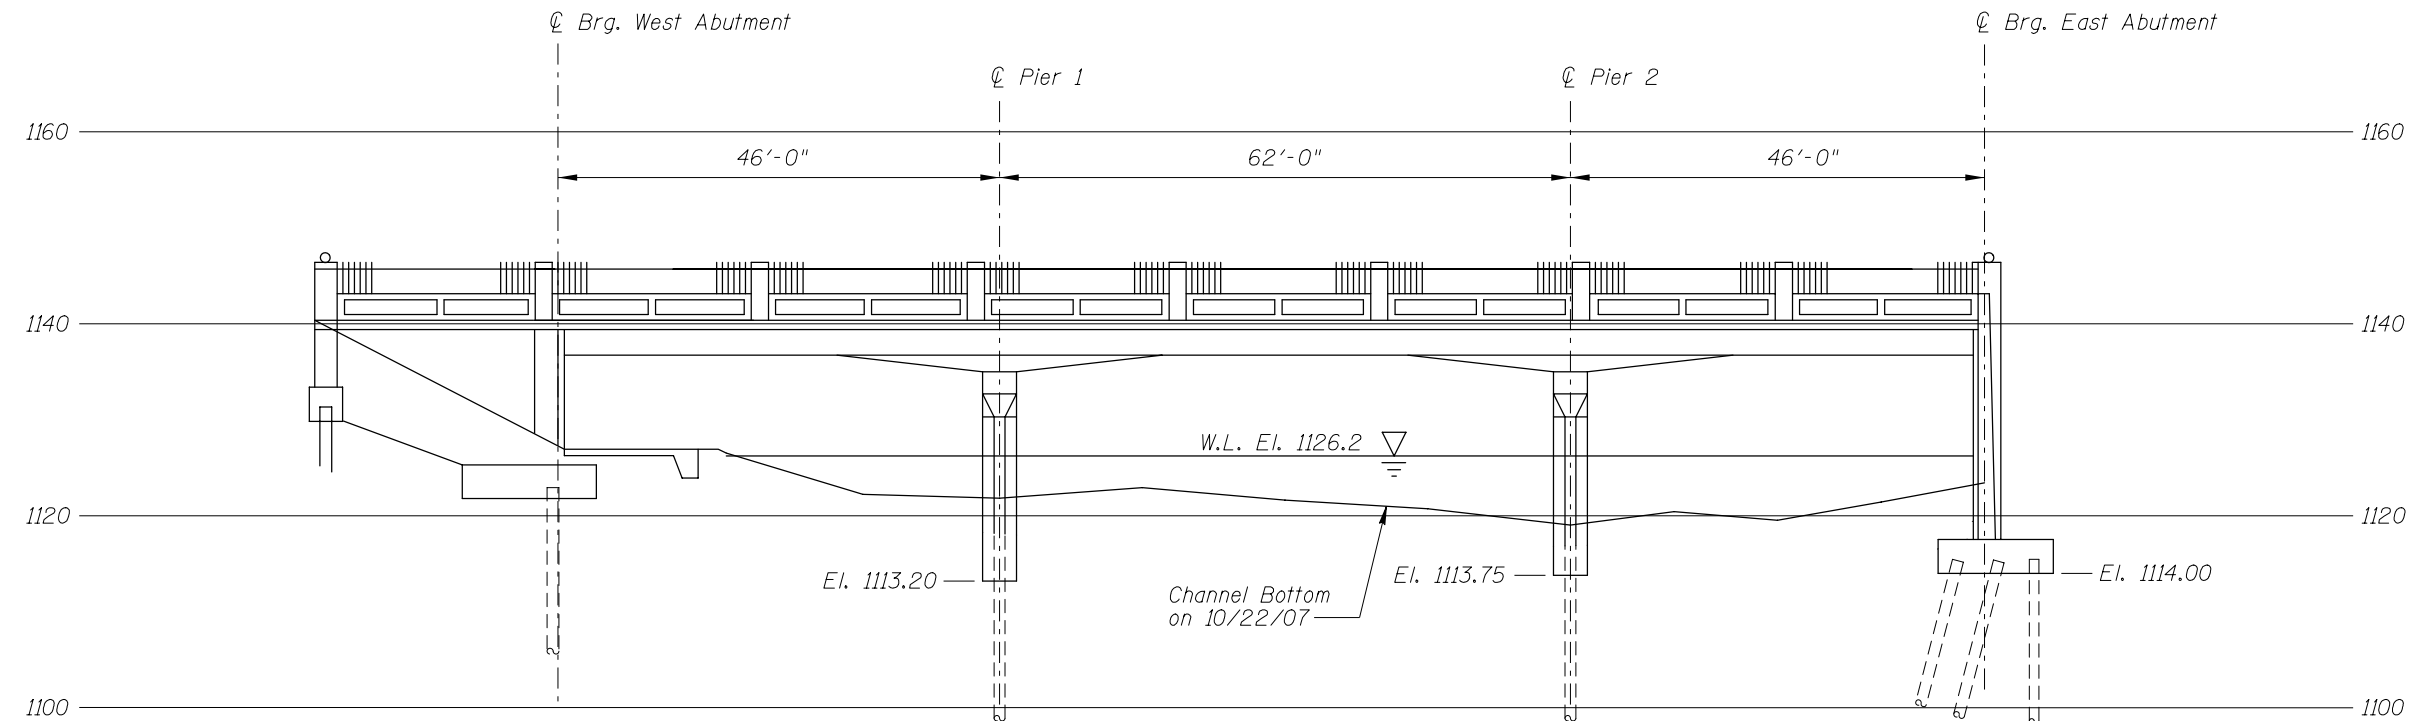
UPSTREAM FASCIA PROFILE

REMARKS: The concrete was in smooth and sound condition with random vertical hairline to 1/32-inch-wide cracking observed in the shafts of Piers 1 and 2 and random hairline to 1/16-inch-wide cracking observed along the breastwall of the East Abutment. The channel bottom typically consisted of 2-foot-diameter and smaller riprap with soft silt interspersed having up to 3 inches of probe rod penetration. There was also some very soft infilling along the west side of Pier 1.

Reinspect the submerged substructure units at the normal maximum recommended (NBIS) interval of five (5) years.
